WORKS INSPECTION & TESTING Bulk Earthworks

**PROPOSED
RESIDENTIAL
DEVELOPMENT**

Pebble Creek Stage 1

JOB NO: P1720 comp01

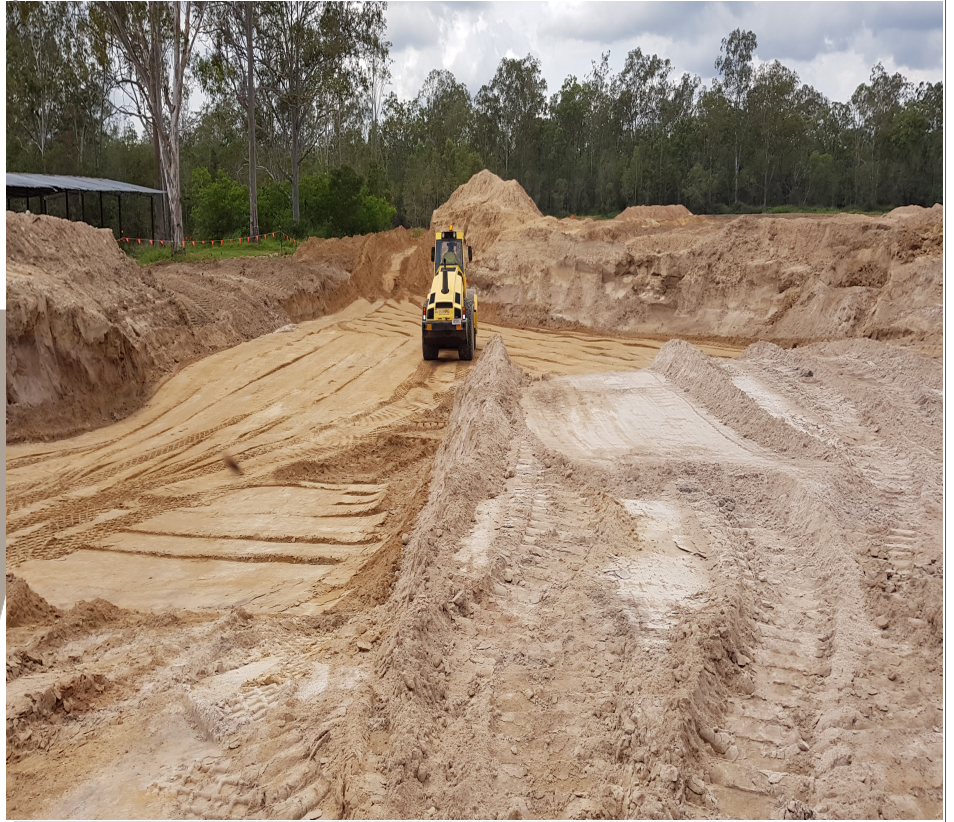
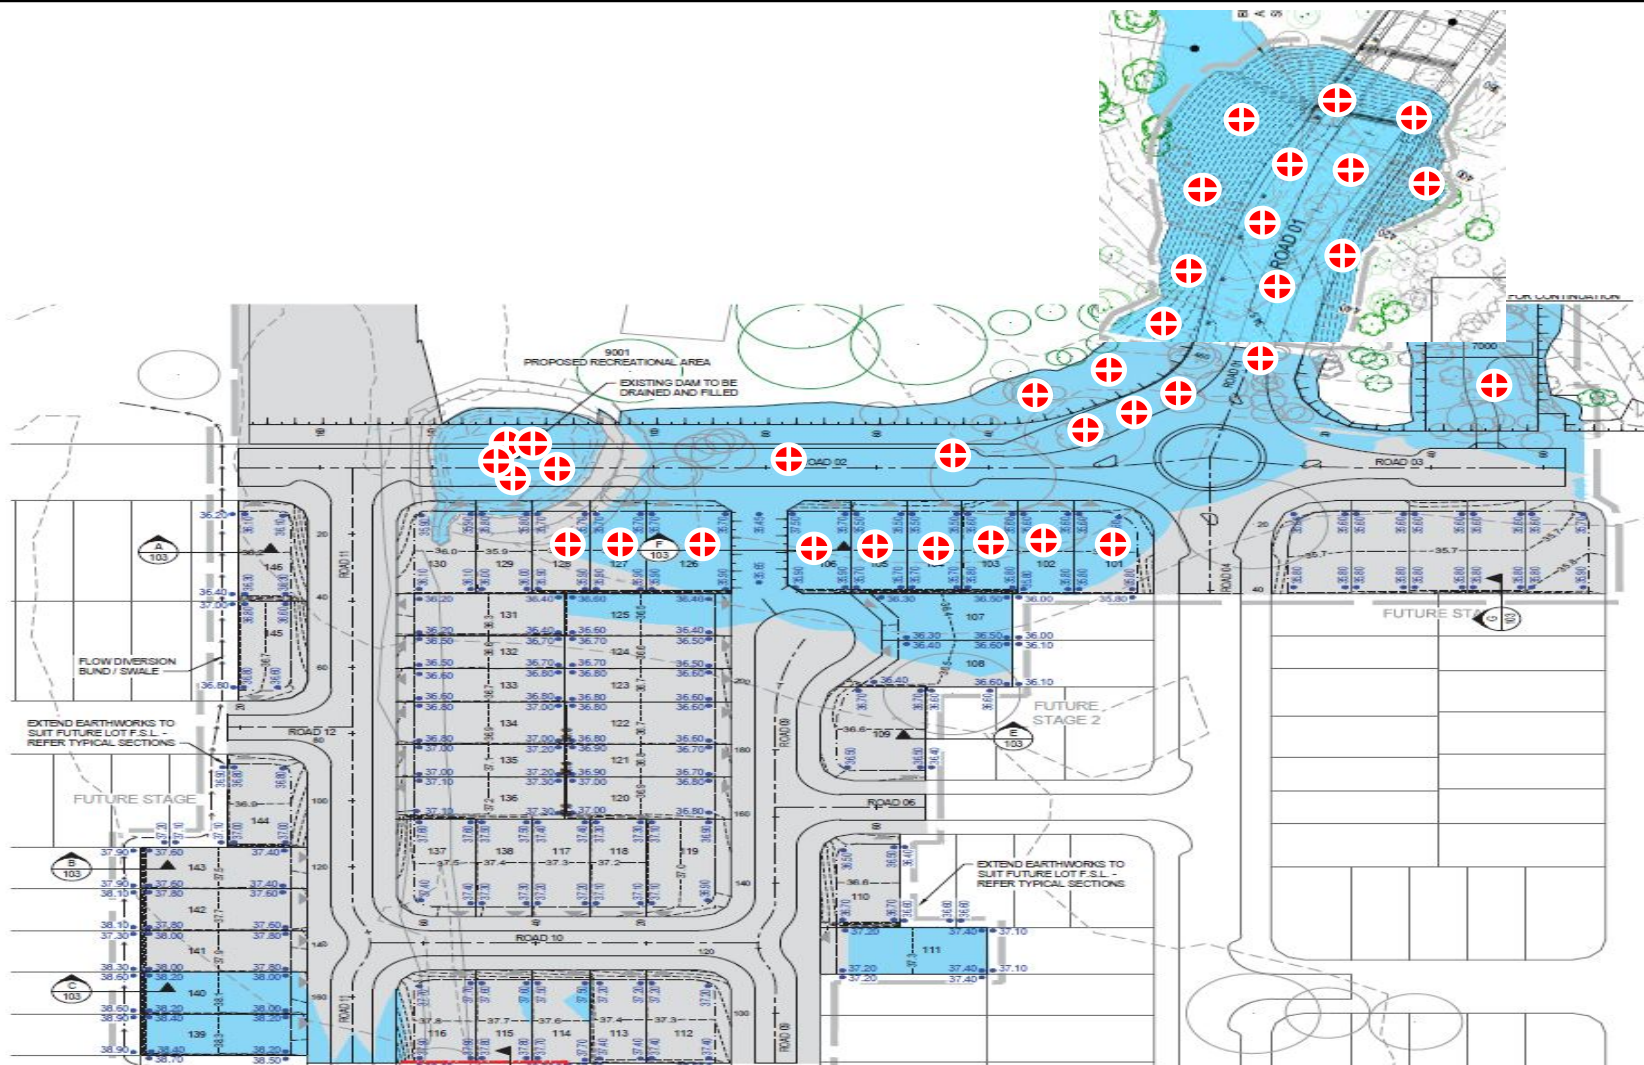
CLIENT: CCA Winslow - Residential Development	JOB No.: P1720
PROJECT: Stage 1 Pebble Creek Road	SKETCH No.: SK 1
TEST ITEM: Bulk Earthworks	DATE ISSUED: 26.07.2019

Denotes Approximate Density Location
