Works Inspection & Testing – Bulk Earthworks

PEBBLE CREEK RESIDENTIAL DEVELOPMENT – STAGE 8

Prepared for BMD Urban Pty Ltd

7th of July 2023

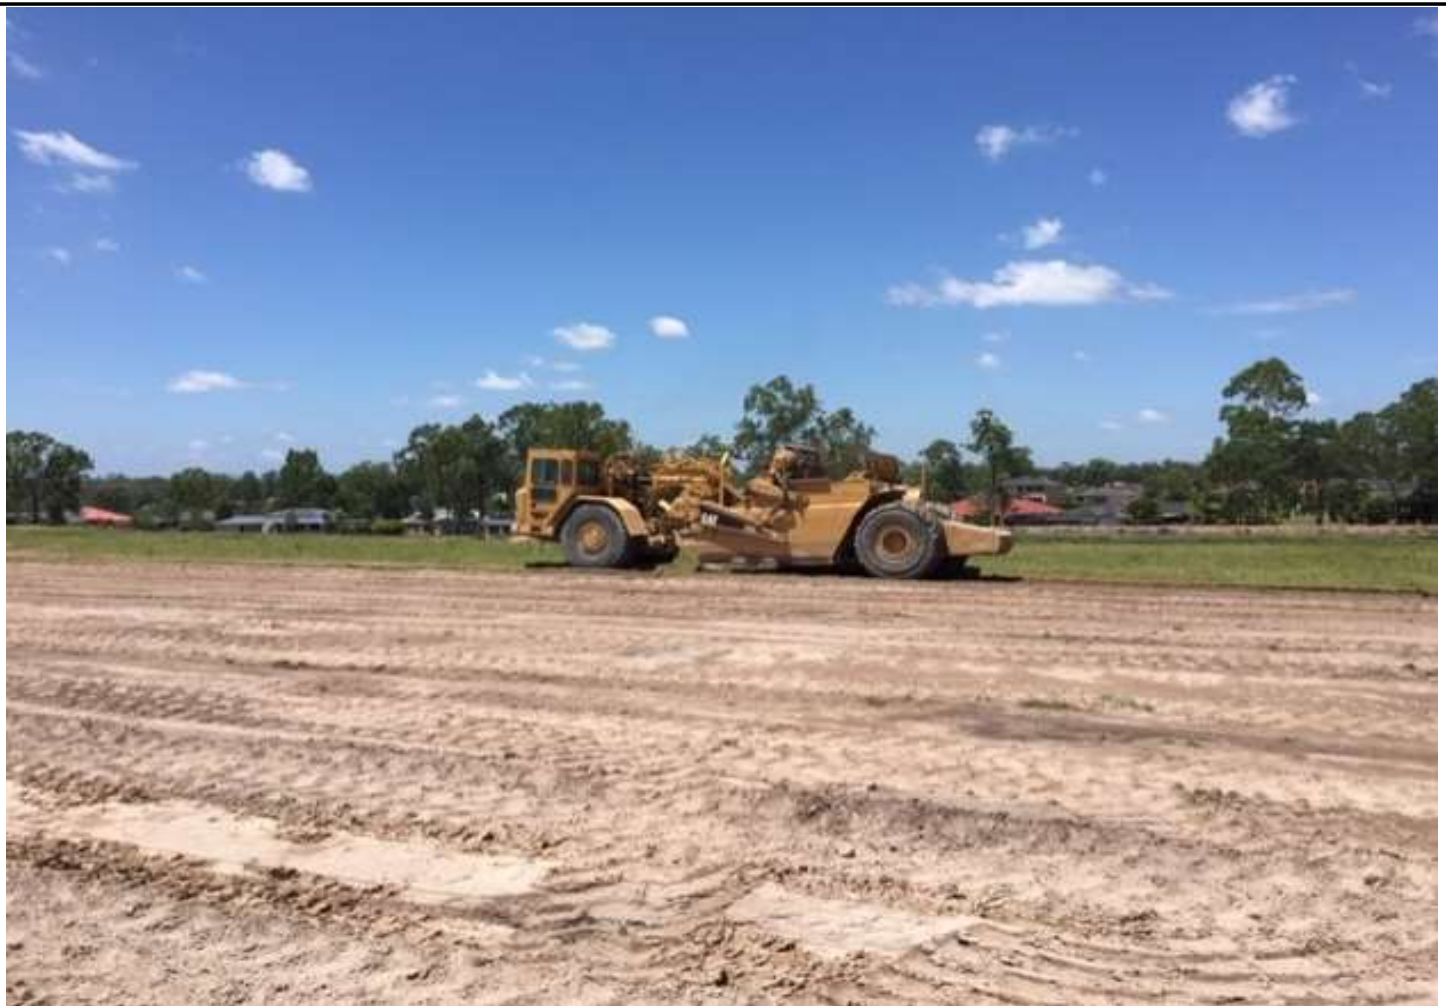
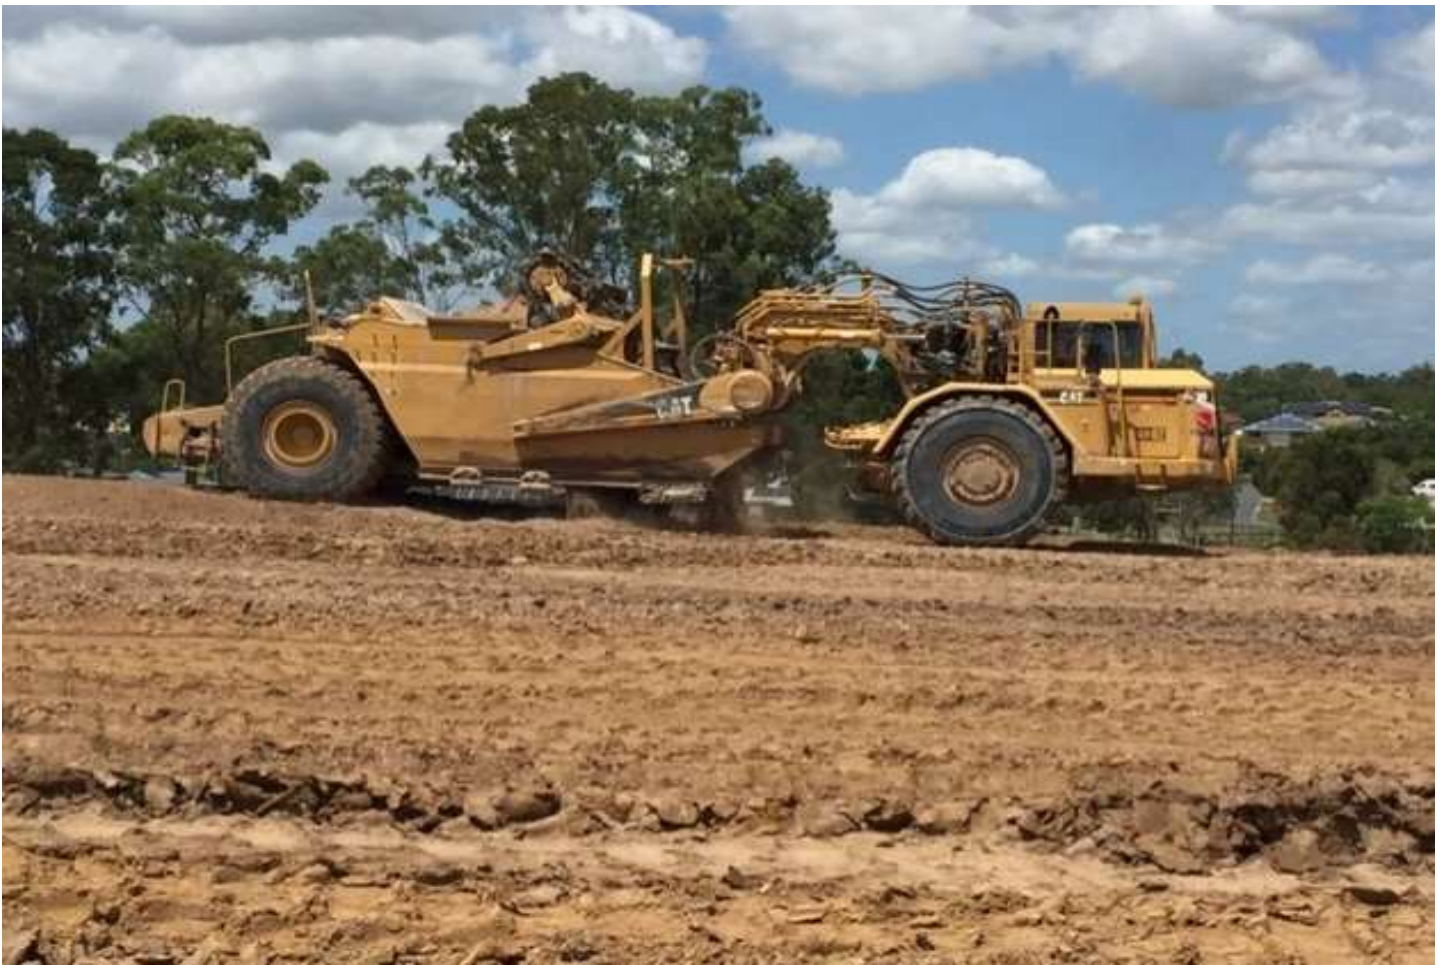
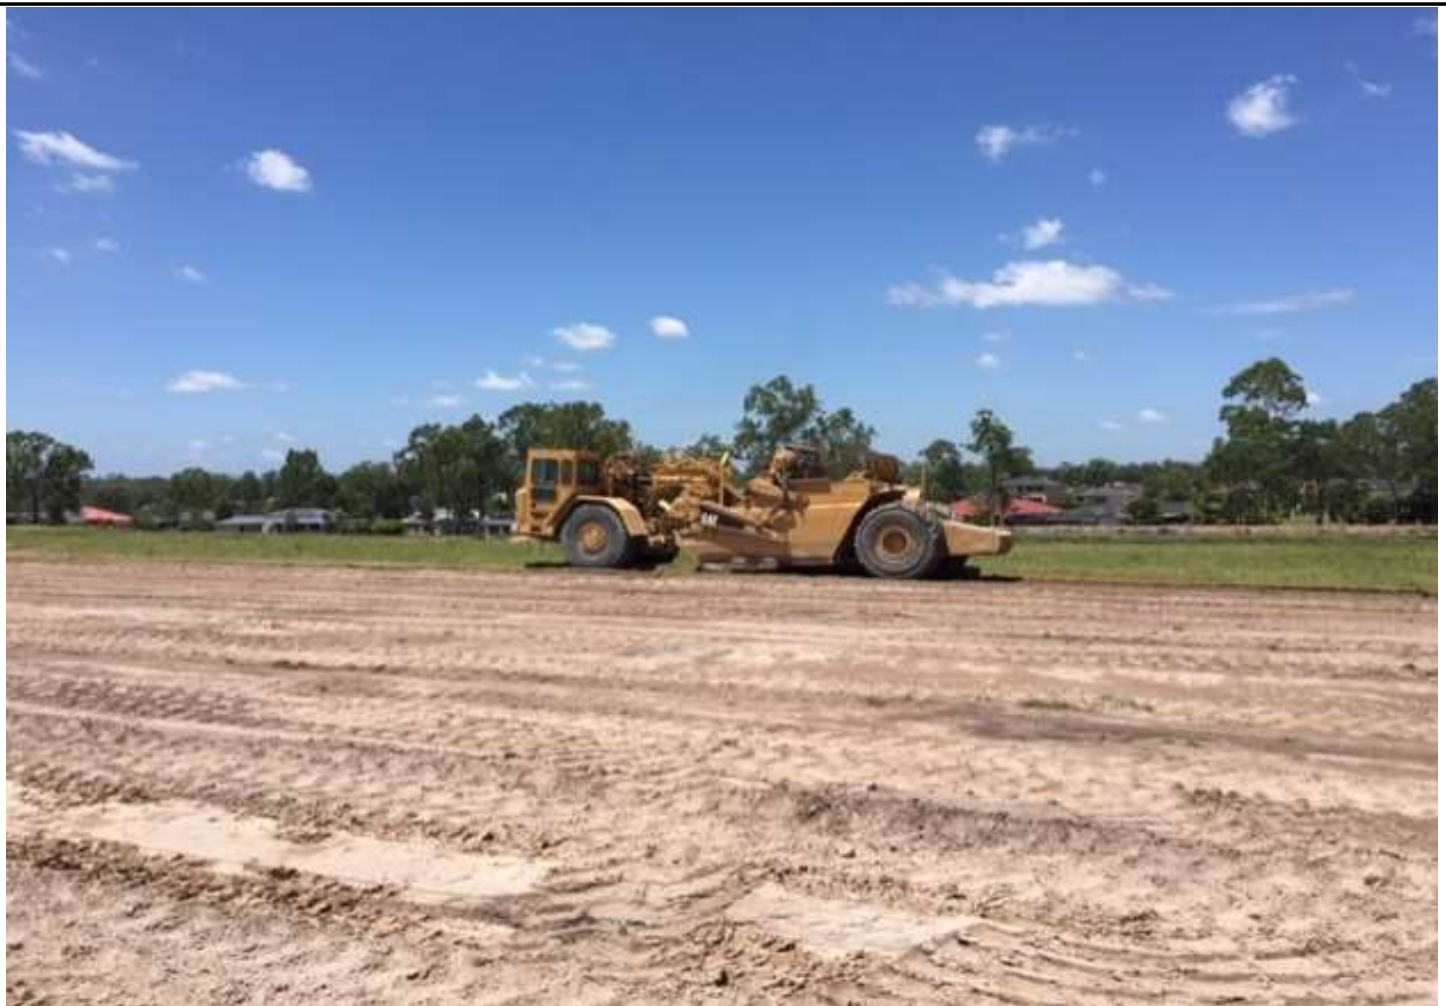
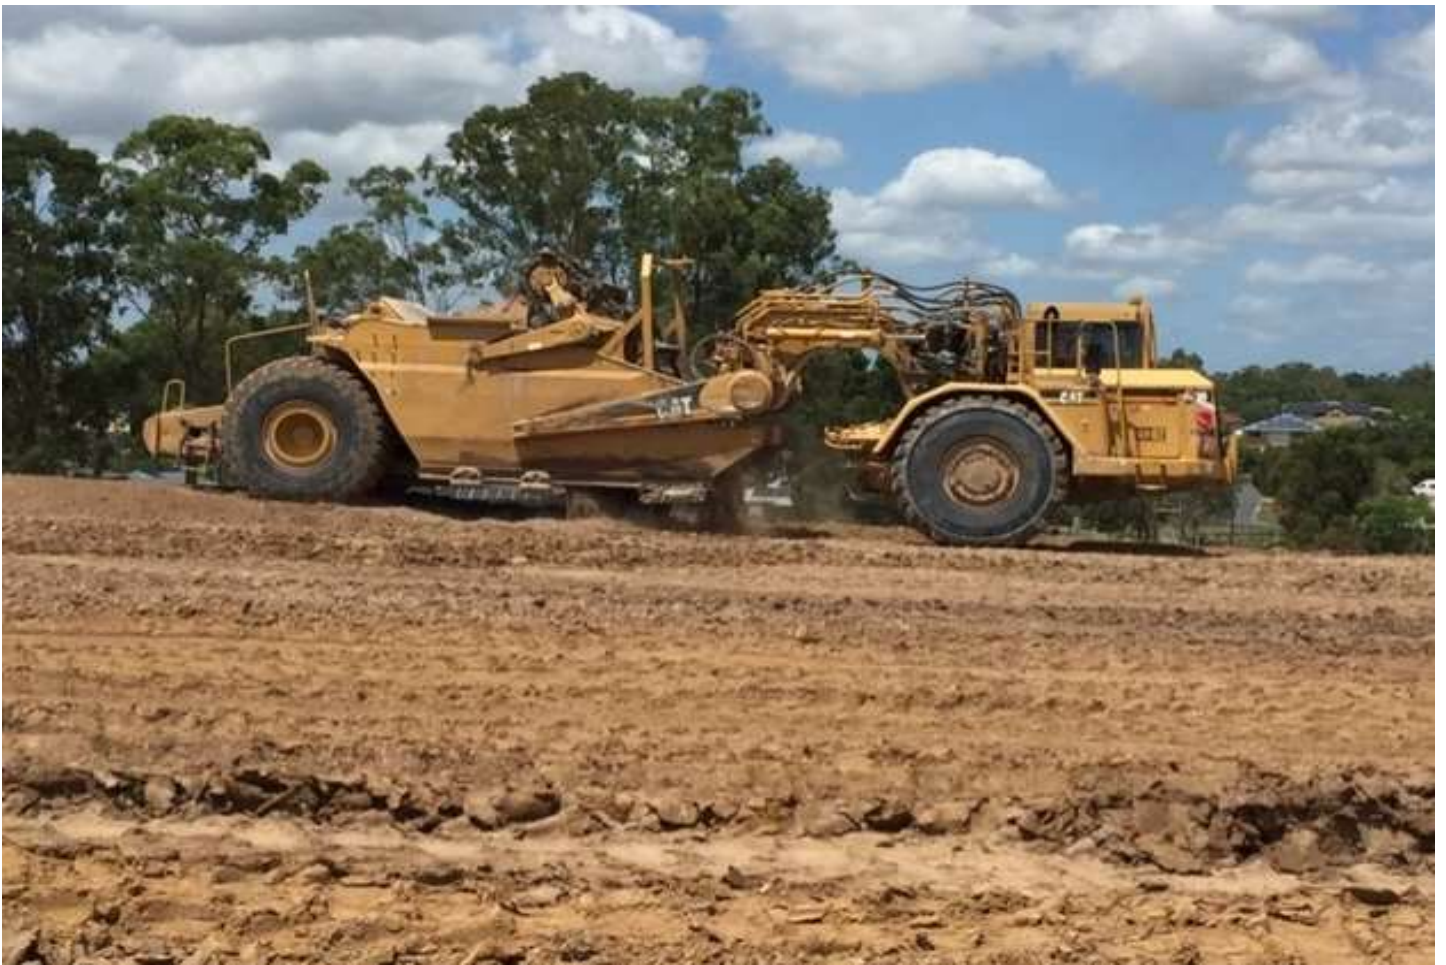
SITE WORKS PHOTOGRAPHS

Progressive photographs taken during the bulk earthworks operations are included in Appendix A.
